Stream Inventory Report

Coleman Valley Creek

Salmon Creek Watershed
Sonoma County, California

Survey: Summer 2002
Final Report: September, 2004

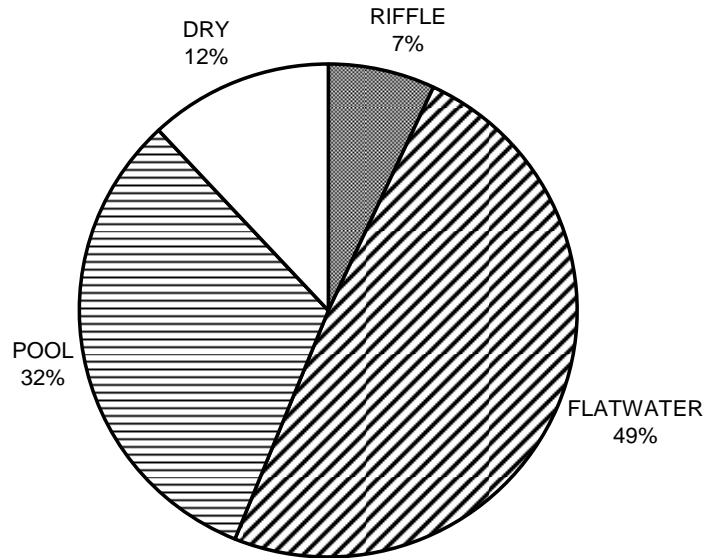
GRAPH 1. Level II habitat types by percent occurrence.

Table 1 summarizes the Level II riffle, flatwater, and pool habitat types. Based on frequency of *occurrence* there were 49.3% Flatwater units, 31.4% Pool units, 11.8% Dry units and 7.4% Riffle units (Graph 1). Based on total *length* there were 48.2% Flatwater units, 26.5% Dry units, 21.6% Pool units and 3.8% Riffle units (Graph 2).

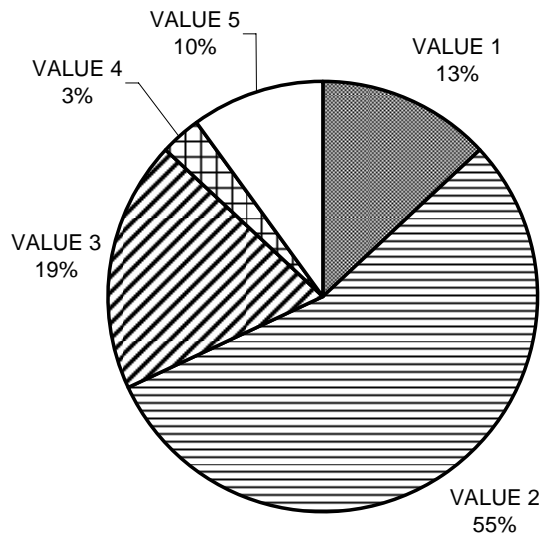
GRAPH 6. Percent embeddedness estimated at pool tail-outs.

The depth of cobble embeddedness was estimated at pool tail-outs. Of the 54 pool tail-outs measured, 4 had a value of 1 (13%), 33 had a value of 2 (55%), 11 had a value of 3 (19%) and 1 had a value of 4 (3%). 5 (10%) riffles rated a 5 (unsuitable substrate type for spawning). On this scale, a value of one is best for fisheries. Gravel was the dominant substrate observed at pool tail-outs (Graph 8). Table 9 describes percent embeddedness by reach.

Seventeen percent of the pool tail-outs measured had embeddedness ratings of either 3 or 4. Only 6% had a rating of 1. Cobble embeddedness measured to be 25% or less (a rating of 1) is considered best for the needs of salmon and steelhead. In a reach comparison, Reach 2 had the best rating and Reach 3 had the poorest rating.

The higher the percent of fine sediment, the lower the probability that eggs will survive to hatch. This is due to the reduced quantity of oxygenated water able to percolate through the gravel, or because of fine sediment capping the redd and preventing fry emergence. In Coleman Valley Creek, sediment sources in all three reaches should be mapped and rated according to their potential sediment yields, and control measures taken.

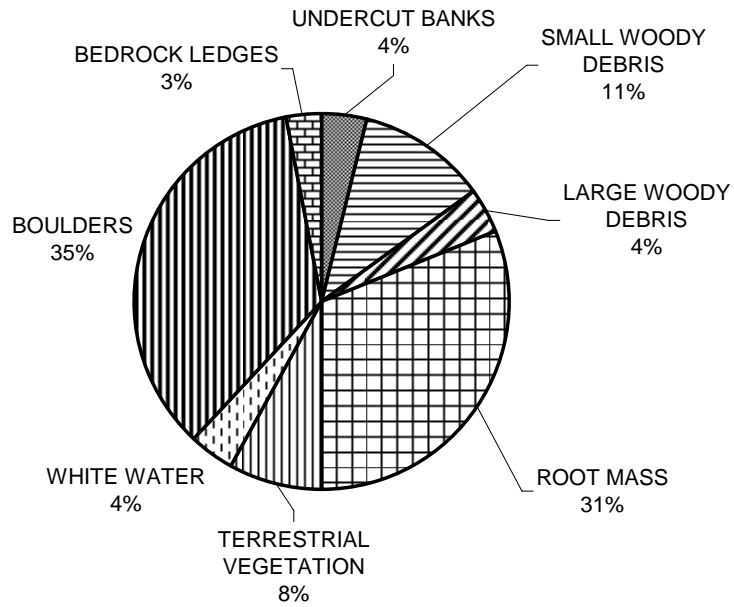
GRAPH 7. Mean percent cover types in pools.

Table 5 summarizes fish shelter by habitat type. By percent area, the dominant pool shelter types were Boulders at 35%, Root Mass at 31%, Small Wood at 11%, Terrestrial Vegetation at 8%, Large Wood at 4%, White Water at 4%, Undercut Banks at 4%, and Bedrock at 3%. Graph 7 describes the pool shelter in Coleman Valley Creek.

The mean shelter rating for pools was 14. A pool shelter rating of approximately 80 is desirable. The relatively small amount of pool shelter that now exists is being provided primarily by Boulders at 35%, Root Mass at 31%, Small Wood at 11%, Terrestrial Vegetation at 8%, Large Wood at 4%, White Water at 4%, Undercut Banks at 4% and Bedrock at 3%. Log and rootwad cover in the pool and flatwater habitats would improve both summer and winter salmonid habitat. Log cover provides rearing fry with protection from predation, rest from water velocity, and also divides territorial units to reduce density related competition.

- 7) Where feasible, increase woody cover in the pool and flatwater habitat units along the entire stream. Most of the existing shelter is from boulders and rootmass. Adding high quality complexity with larger woody cover is desirable. Combination cover/scour structures constructed with boulders and woody debris would be effective in many flatwater and pool locations throughout the stream. This must be done where the banks are stable (Reach 2) or in conjunction with stream bank armor to prevent erosion (Reach 1). In some areas the material is at hand.

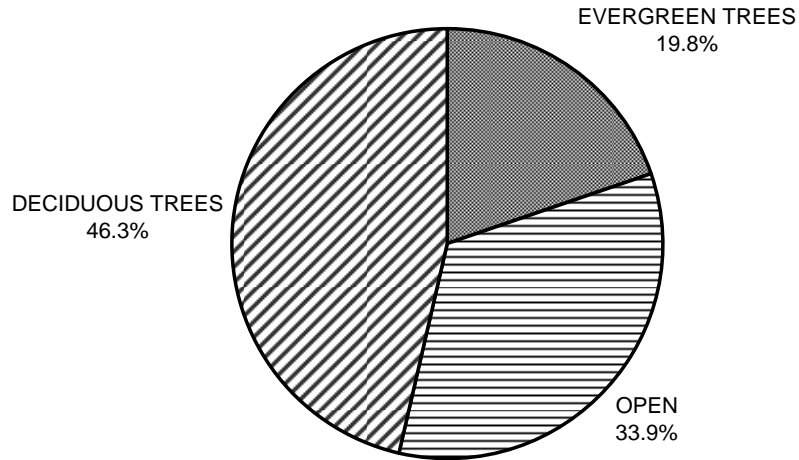
GRAPH 9. Mean percent canopy.

The mean percent canopy density for the stream reach surveyed was 65%. The mean percentages of deciduous and evergreen trees were 72% and 20%, respectively. Graph 9 describes the canopy for the entire survey and Table 9 describes the canopy by reach.

The mean percent canopy for the survey was 65%. This is fair since 80 percent is generally considered desirable. However, Reach 1 had a canopy of 59% with areas of bank erosion problems. Although water temperatures in Coleman Valley Creek are favorable to salmonids, increased canopy would eliminate hotspots that were observed in some reaches. Planting large trees required for adequate stream canopy would also eventually provide a long term source of large woody debris needed for instream shelter and bank stability. Reach 1 as well as other areas with bank erosion could benefit from bio-technical re-vegetation techniques using native species.

- 5) Increase the canopy on Coleman Valley Creek by planting willow, alder, redwood, and Douglas fir along the stream where shade canopy is not at acceptable levels (portions of Reaches 1 and 2). The non-anadromous reach above the survey section

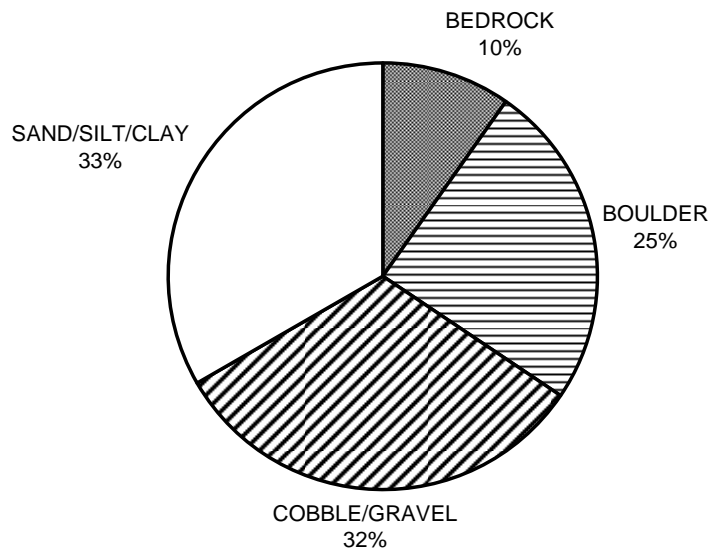
GRAPH 10. Dominant bank composition in survey reach.

For the entire stream reach surveyed, the mean percent right bank vegetated was 20% and the mean percent left bank vegetated was 18%. For the habitat units measured, the dominant vegetation types for the stream banks were: 45% Deciduous Trees, 16% Grass, 14% Bare Soil, 13% Brush and 9% Evergreen Trees (Graph 11). The dominant substrate for the stream banks were: 33% Silt, Clay & Sand, 31% Cobble & Gravel, 25% Boulder and 10% Bedrock (Graph 10).
