# Stream Inventory Report

## Finley Creek

Salmon Creek Watershed  
Sonoma County, California

Survey: Summer 2002  
Final Report: September, 2004

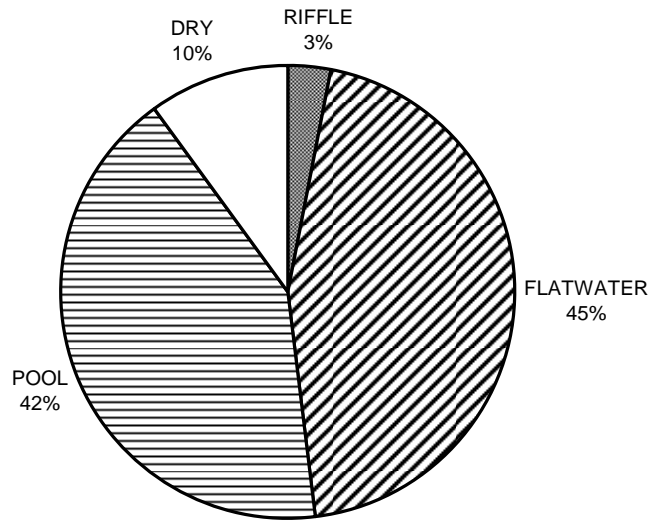
GRAPH 1. Level II habitat types by percent occurrence.

Table 1 summarizes the Level II riffle, flatwater, and pool habitat types. Based on frequency of *occurrence* there were 44.8% Flatwater units, 41.6% Pool units, 10.4% Dry units and 3.2% Riffle units (Graph 1). Based on total *length* there were 67.3% Flatwater units, 18.5% Pool units, 11.7% Dry units and 2.5% Riffle units (Graph 2).

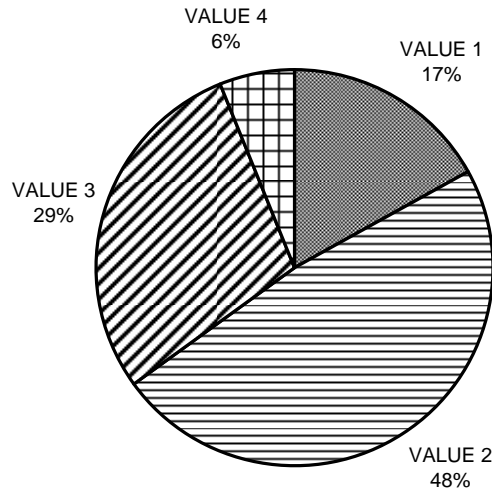
GRAPH 6. Percent embeddedness estimated at pool tail-outs.

The depth of cobble embeddedness was estimated at pool tail-outs. Of the 88 pool tail-outs measured, 15 had a value of 1 (17%), 41 had a value of 2 (48%), 25 had a value of 3 (28%) and 5 had a value of 4 (6%). Riffles rated a 5 (unsuitable substrate type for spawning). On this scale, a value of one is best for fisheries. Gravel was the dominant substrate observed at pool tail-outs (Graph 8). Graph 6 describes percent embeddedness by reach. No mechanical gravel sampling was conducted in 2002 surveys due to inadequate staffing levels.

Thirty-four percent of the pool tail-outs measured had embeddedness ratings of either 3 or 4. Only 16% had a rating of 1. Cobble embeddedness measured to be 25% or less (a rating of 1) is considered best for the needs of salmon and steelhead. In a reach comparison, Reaches 1 and 2 had the best ratings (fair) and Reaches 3 and 4 had the poorest ratings (poor and very poor, respectively).

- 9) Conduct gravel sampling. Results of future sampling may indicate the need for structures which decrease channel incision, recruit and sort spawning gravel, and expand redd distribution in the stream.

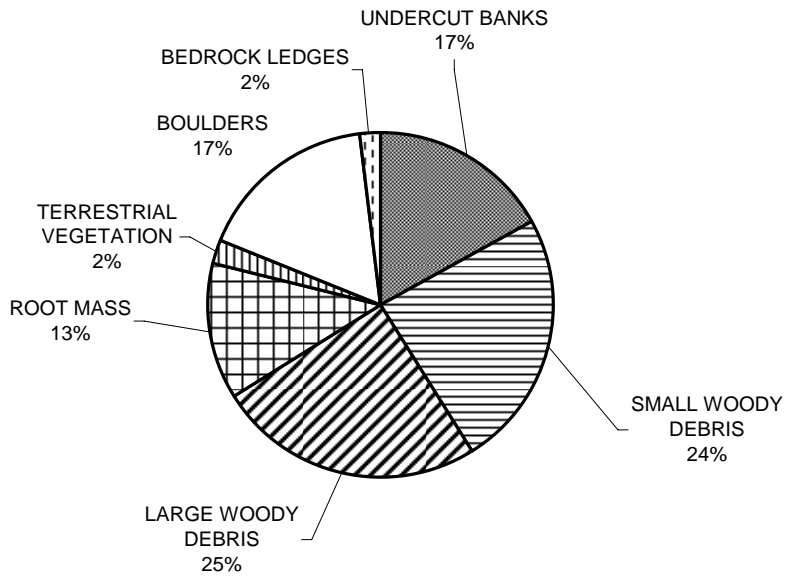
GRAPH 7. Mean percent cover types in pools.

Table 5 summarizes fish shelter by habitat type. By percent area, the dominant pool shelter types were Large Wood at 25%, Small Wood at 24%, Undercut Banks at 17%, Boulders at 17%, Root Mass at 13%, Bedrock at 2%, and Terrestrial Vegetation at 2%. Graph 7 describes the pool shelter in Finley Creek.

The mean shelter rating for pools was 25%. A pool shelter rating of approximately 80% is desirable. The relatively small amount of pool shelter that now exists is being provided primarily by Large Wood at 25%, Small Wood at 24%, Undercut Banks at 17%, Boulders at 17%, Root Mass at 13%, Bedrock at 2%, and Terrestrial Vegetation at 2%. Log and root wad cover in the pool and flatwater habitats would improve both summer and winter salmonid habitat. Log cover provides rearing fry with protection from predation, rest from water velocity, and also divides territorial units to reduce density related competition.

- 4) Where feasible, increase woody cover in the pool and flatwater habitat units along the entire stream. Adding high quality complexity with larger woody cover is desirable. Combination cover/scour structure with boulders and woody debris would be effective in many flatwater and pool locations throughout the creek. This must be done where the banks are stable (Reach 3) or in conjunction with stream bank armor to prevent erosion (Reaches 1 and 2). In some areas the material is at hand.

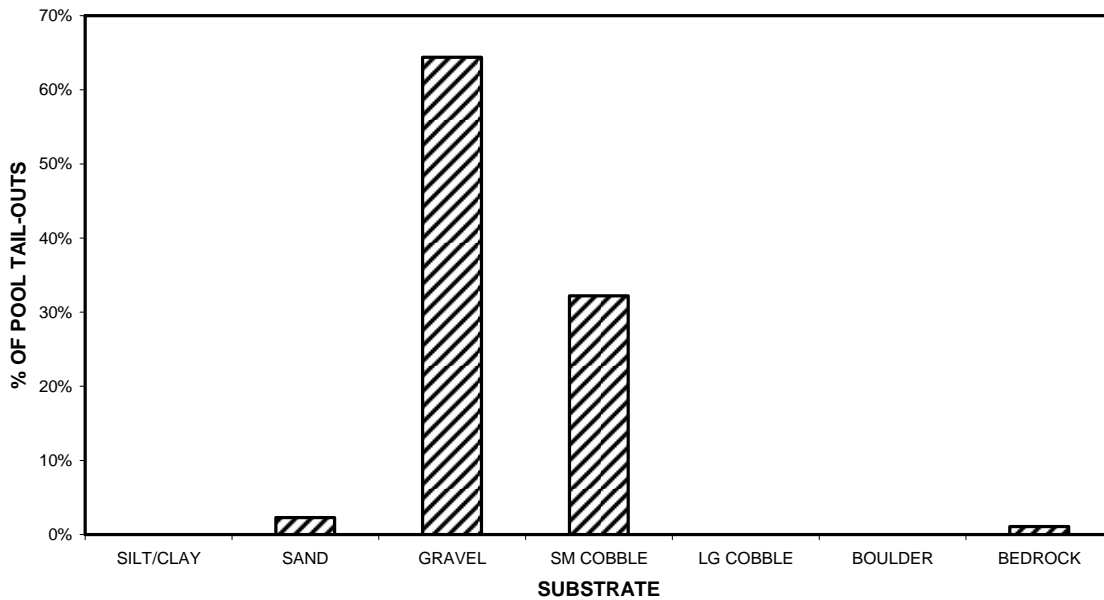
GRAPH 8. Substrate composition in pool tail-outs.

Table 6 summarizes the dominant substrate by habitat type. In five of seven Low-Gradient Riffles completely surveyed, the dominant substrate was: Small Cobble in three riffles and Gravel in two riffles (Graph 8).

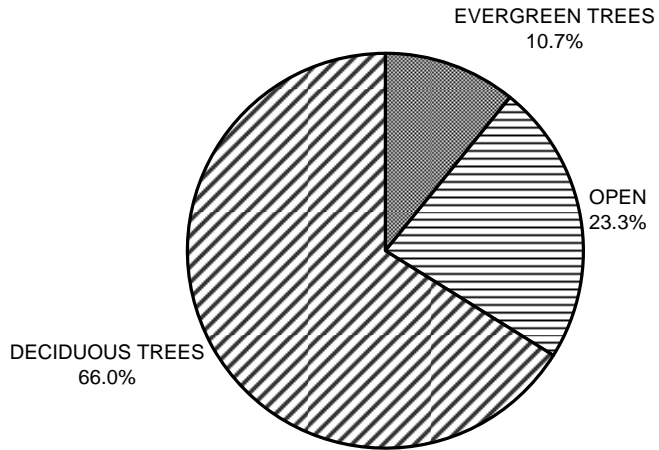
GRAPH 9. Mean percent canopy.

The mean percent canopy density for the stream reach surveyed was 77%. The mean percentages of deciduous and evergreen trees were 86% and 14%, respectively. Graph 9 describes the canopy for the entire survey and Table 7 describes mean percent vegetative canopy cover for the entire surveyed stream.

The mean percent canopy for the survey was 78%. This is good, since 80 percent is generally considered desirable, however, the riparian buffer is thin or nearly absent in areas with livestock. Riparian removal caused by intensive grazing within the riparian corridor will lead to less stream canopy and channel incision causing bank erosion and higher water temperatures.

- 7) Increase the canopy on Finley Creek by planting willow, alder, redwood, and Douglas fir along the stream where shade canopy is not at acceptable levels (portions of Reach 1 and 3). The non-anadromous reach above the survey section should be assessed for planting and treated as well, since water temperatures throughout are affected from upstream. In many cases, planting will need to be coordinated to follow bank stabilization or upslope erosion control projects.

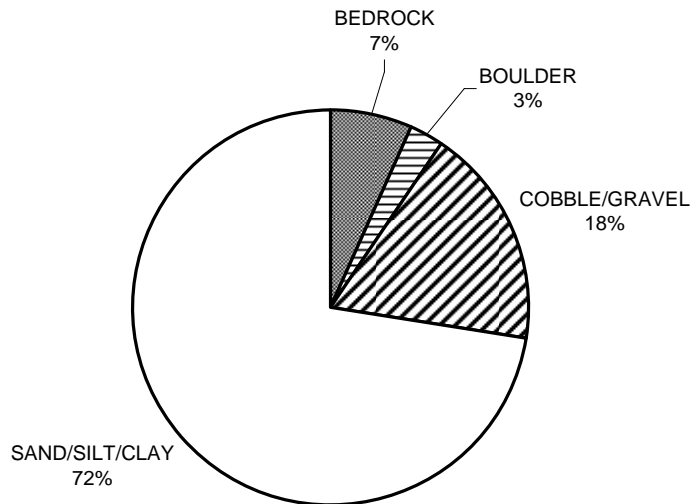
GRAPH 10. Dominant bank composition in survey reach.

For the entire stream reach surveyed, the mean percent right bank vegetated was 29% and the mean percent left bank vegetated was 29% (Table 7). For the habitat units measured, the dominant vegetation types for the stream banks were: 65% Deciduous Trees, 16% Brush, 12% Grass, 5% Evergreen Trees and 2% Bare Soil (Graph 11). The dominant substrate for the stream banks were: 72% Silt, Clay & Sand, 17% Cobble & Gravel, 7% Bedrock and 3% Boulder (Graph 10).
