# Green Valley Creek Watershed Management Plan

**A Living Document to Facilitate the Stewardship of the Green Valley  
Creek Watershed**

**The Green Valley Creek**  
**Watershed Management Plan DRAFT**  
**Phase II, March 2013**

**Gold Ridge Resource Conservation District**

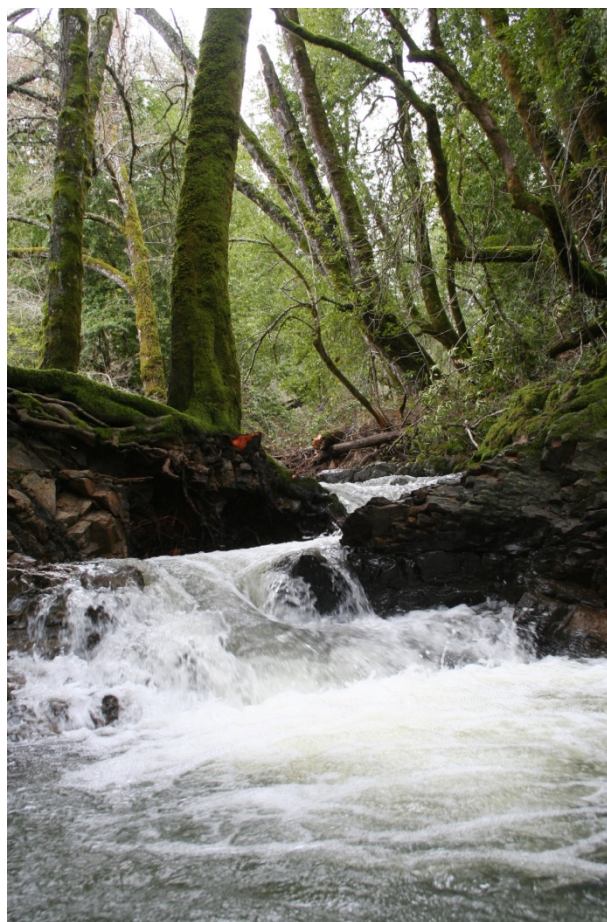
Figure B-1. Map of Green Valley Creek Watershed Water Quality Monitoring Stations

Since late 2008, the Gold Ridge Resource Conservation District (GRRCD) has been monitoring water quality at select locations throughout the Atascadero-Green Valley Creek watershed to document water quality conditions, track trends and ultimately, to determine if water quality conditions are a limiting factor to sensitive aquatic organisms. Surface water samples from creeks (when available, some locations go dry during the summer in some years) were collected monthly from each monitoring location via grab sample. Grab sampling takes a snapshot of the water quality conditions occurring at a specific location at the time of sampling. Parameters including instantaneous temperature, dissolved oxygen (DO), pH, and specific conductivity were measured directly in the field using a YSI hand-held water quality meter; turbidity was also measured using a HACH Turbidimeter. During storm sampling grab samples were collected and sent to a laboratory for nutrient (ammonia, nitrate and orthophosphate) and Total Suspended Solids (TSS) analyses.

In addition to the ongoing monthly grab sampling, two multi-parameter meters were deployed in Green Valley Creek in the summers of 2011 and 2012 to track continuous water quality conditions throughout the summer and early fall. These meters collected water temperature, dissolved oxygen (DO), pH, and specific conductivity measurements every 30 minutes.

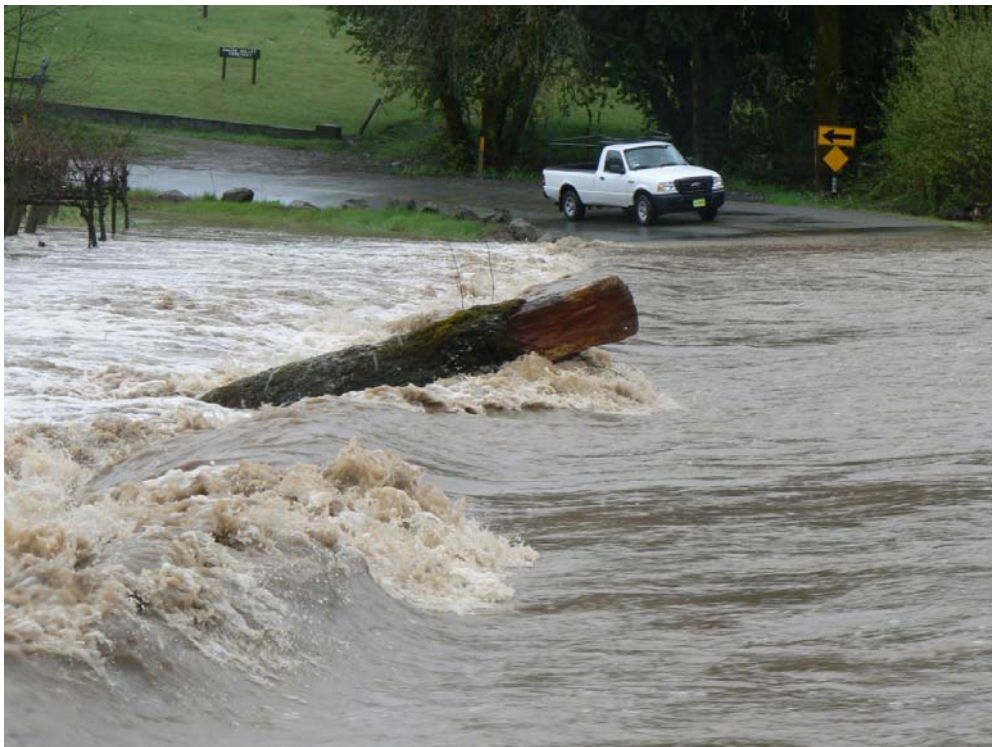
*Photo of Green Valley Creek flood waters coursing over Green Valley Road on March 23, 2011*

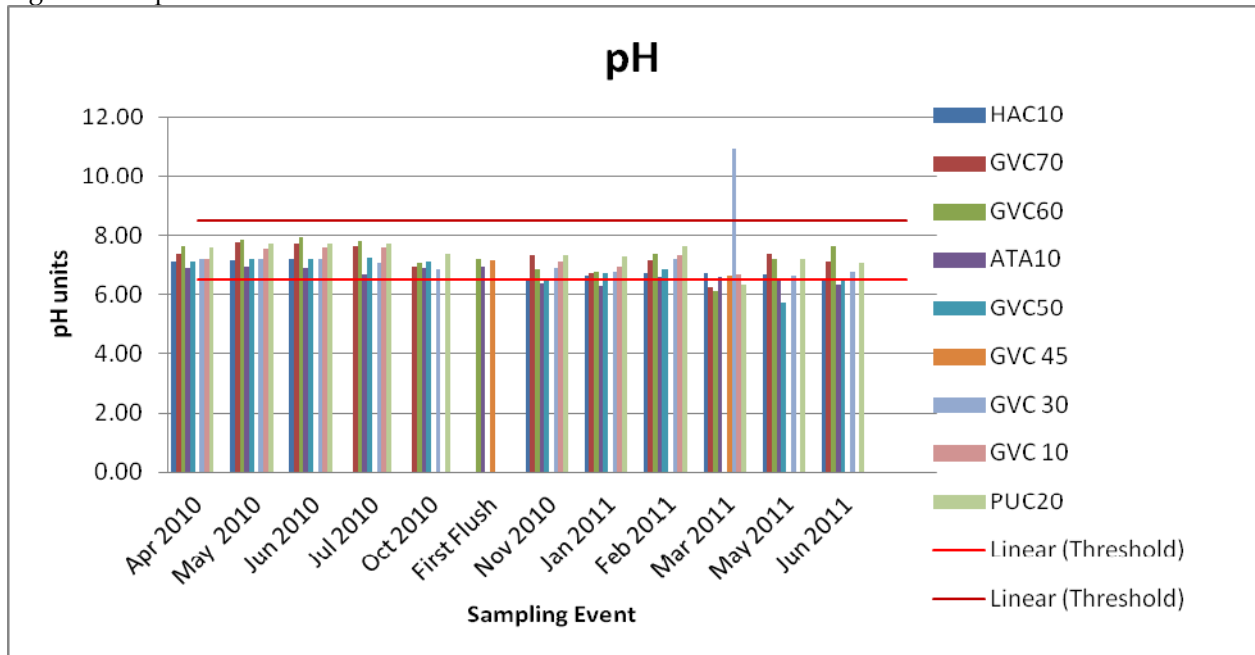
Figure B-17. pH Measurements 2010-2011

For fish, pH above 9.5 can cause death or damage to outer surfaces like gills, eyes, and skin, and result in an inability to dispose of metabolic wastes. Increased pH can also increase the toxicity of other substances, such as ammonia; the effect of ammonia is 10 times greater at pH 8 than at pH 7. When conditions are more acidic (low pH), plankton and mosses may invade, and some fish populations diminish. Water Quality Objectives from the North Coast Regional Water Quality Control Plan set pH 8.5 as the maximum and 6.5 as the minimum for the Lower Russian River Watershed (NCRWQCB 2007a).

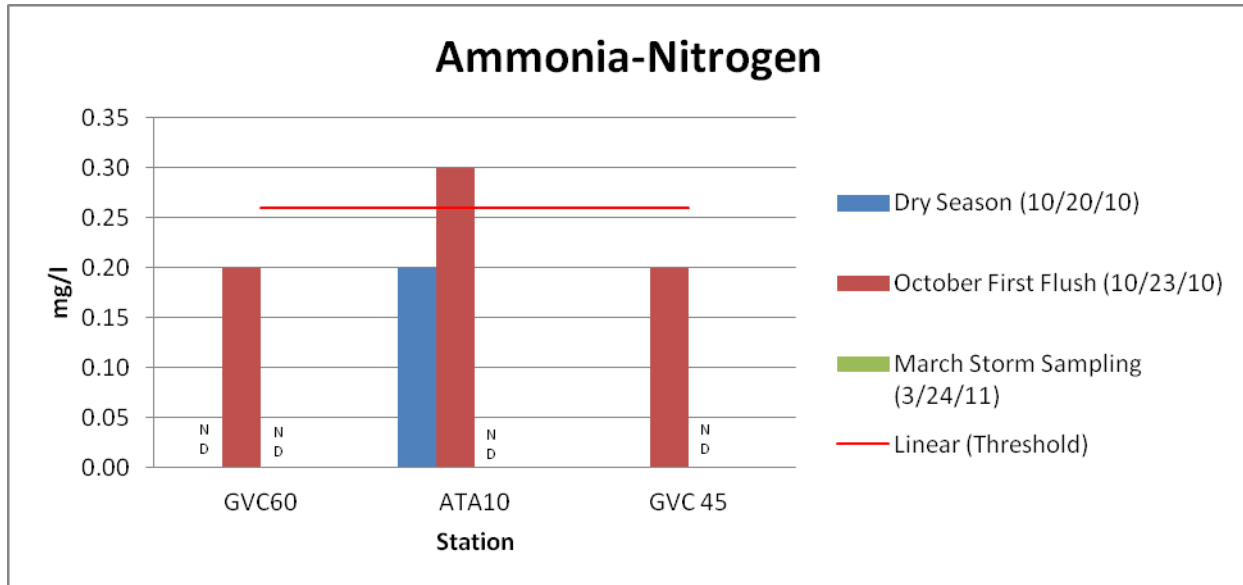
Figure B-20. Ammonia Measurements from Selected Storm Events

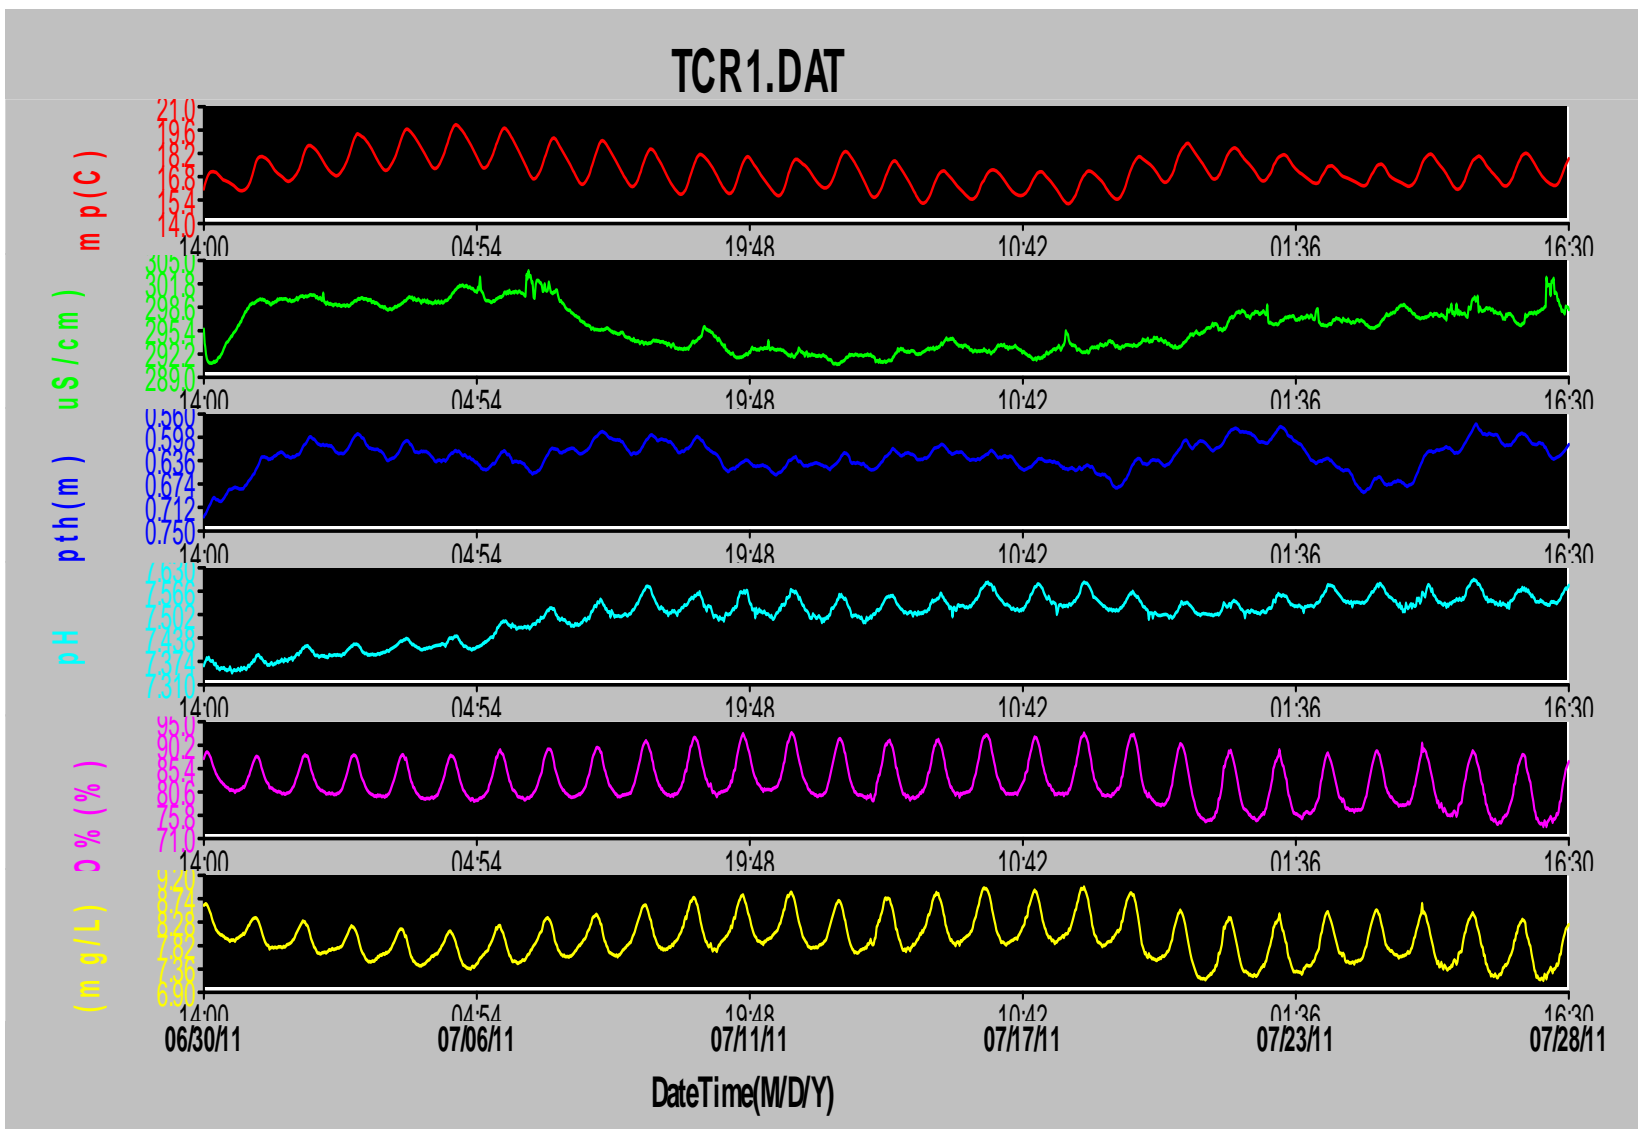
Figure B-23. Continuous water quality data for Green Valley Creek as it runs through GVC47 (6/30/11-7/28/11)

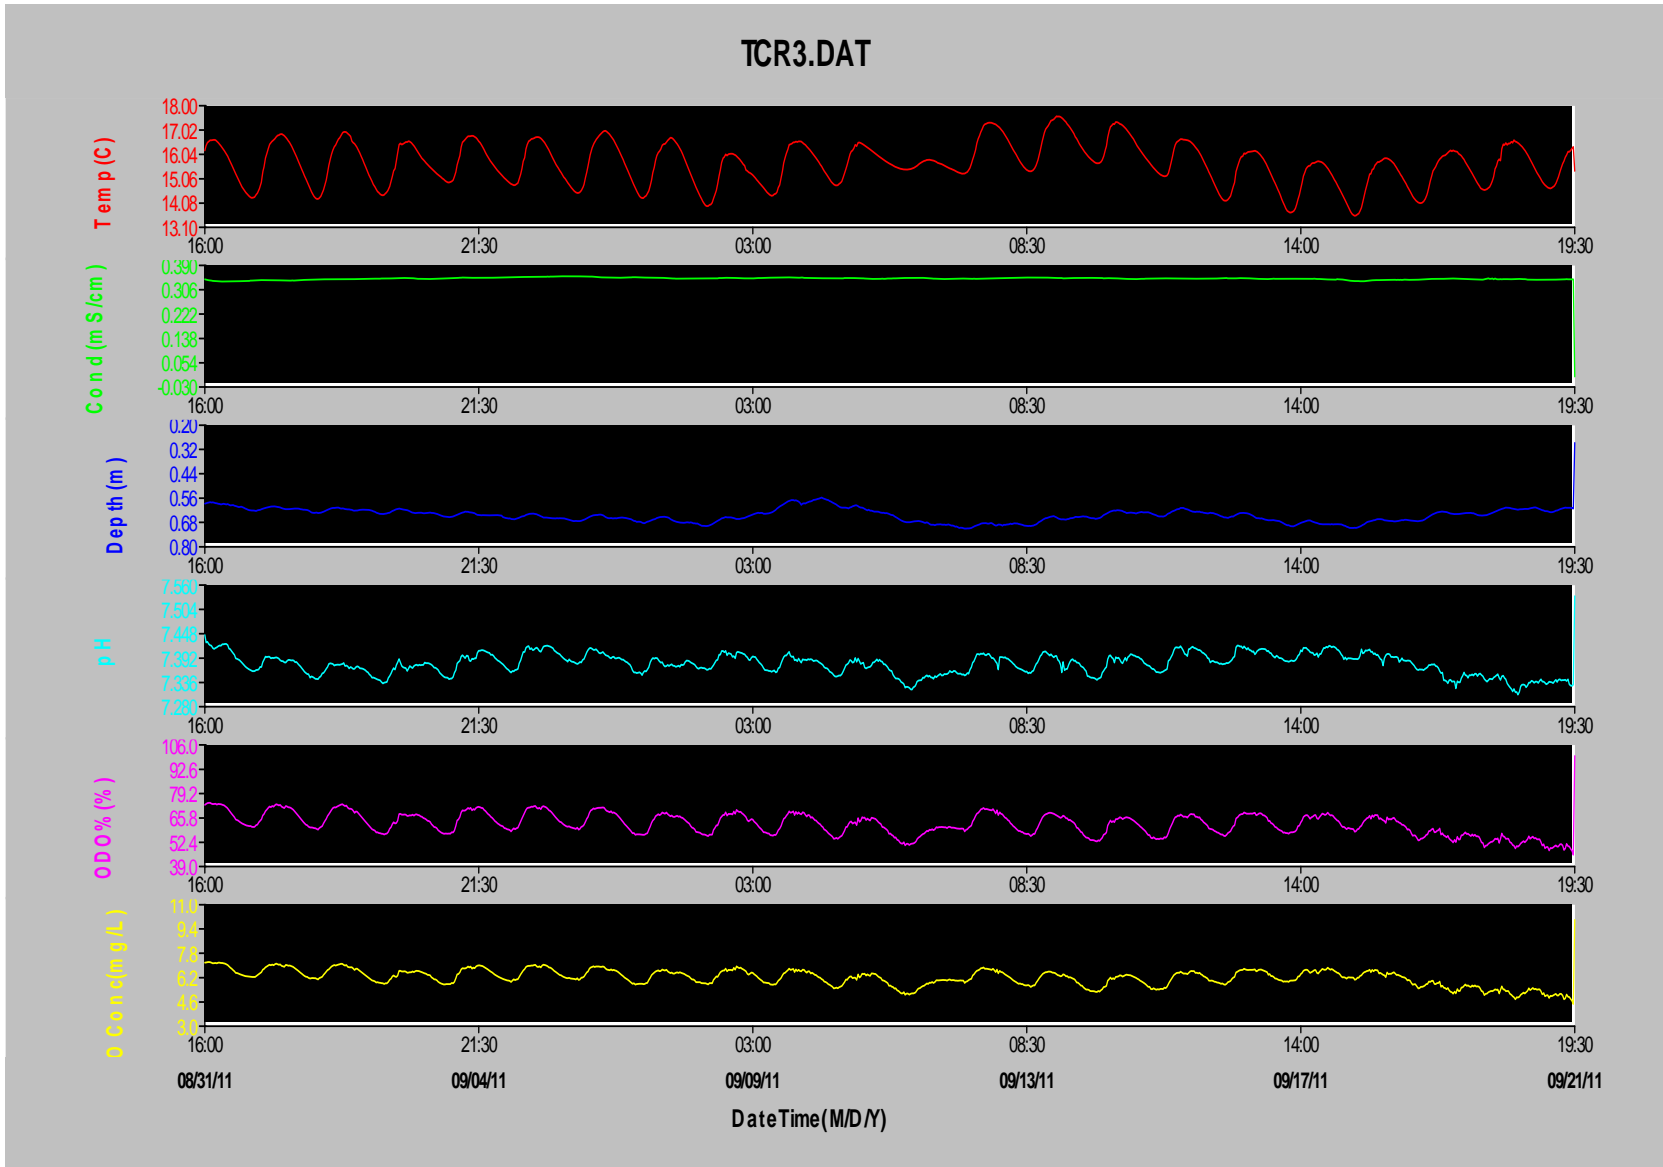
Figure B-25. Continuous water quality data for Green Valley Creek as it runs through GVC47 (8/31/11-9/21/11)

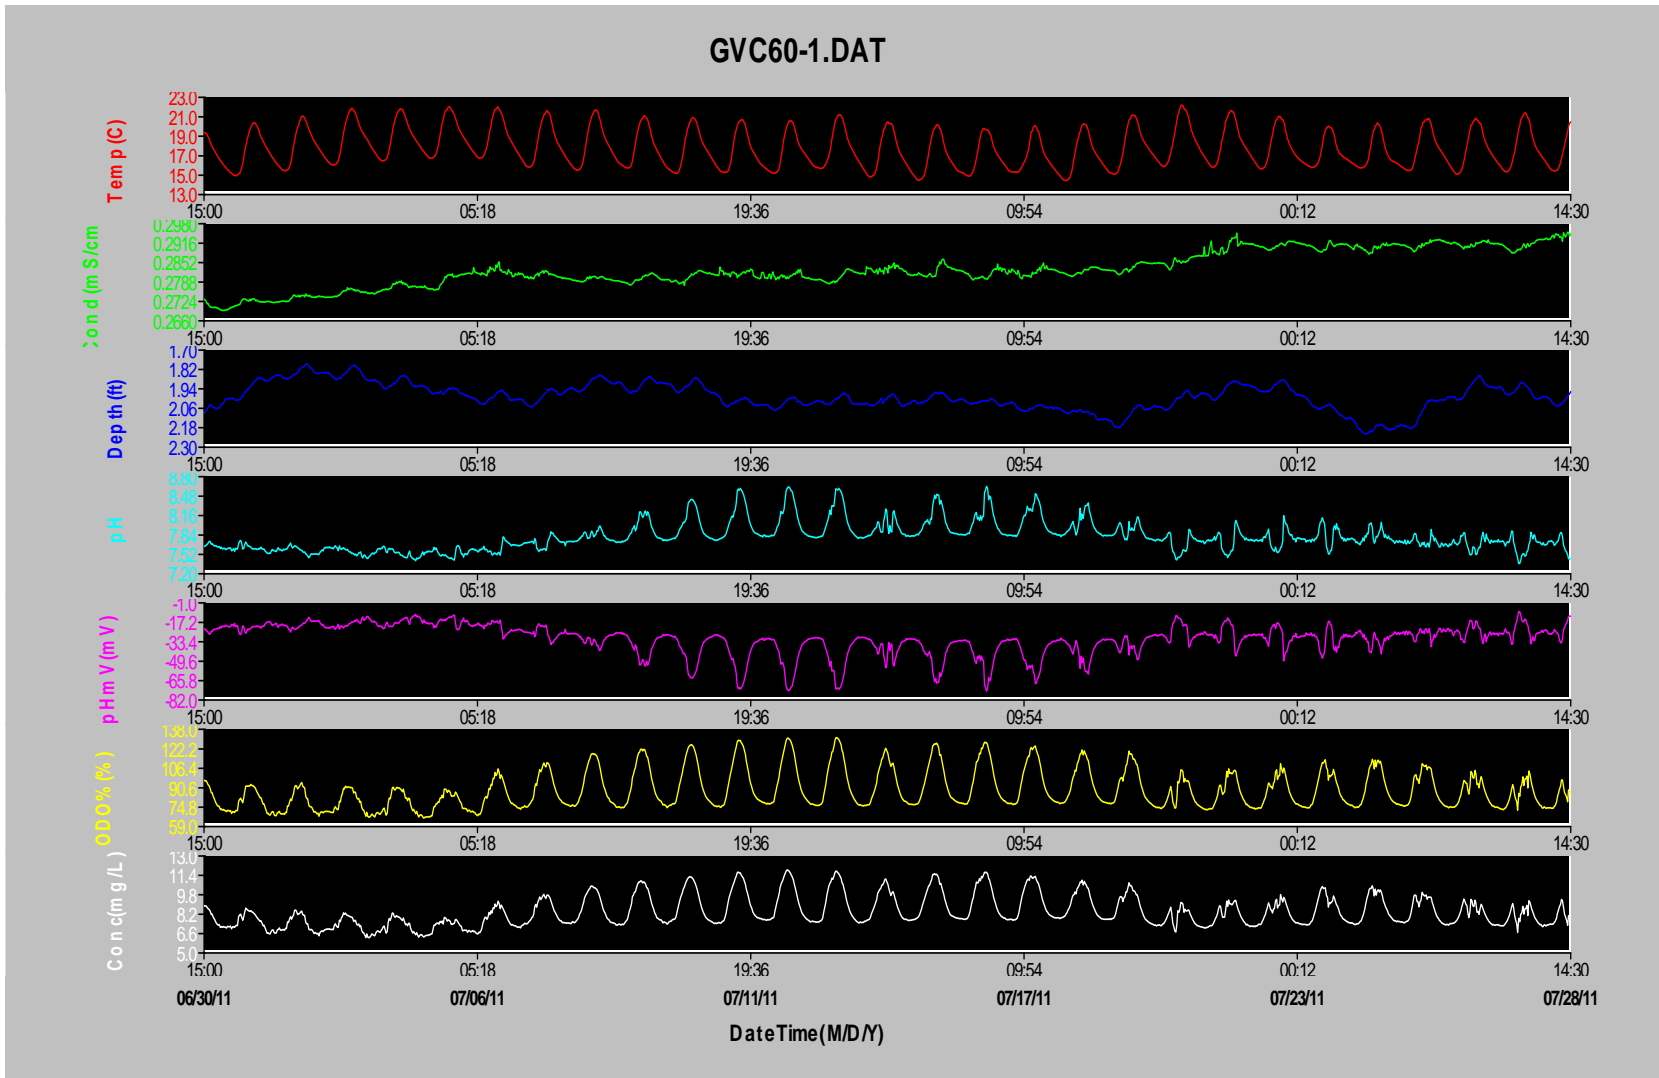
Figure B-26. Continuous water quality data for GVC60, Green Valley Creek downstream of Green Valley Road bridge (6/30-7/28/11)

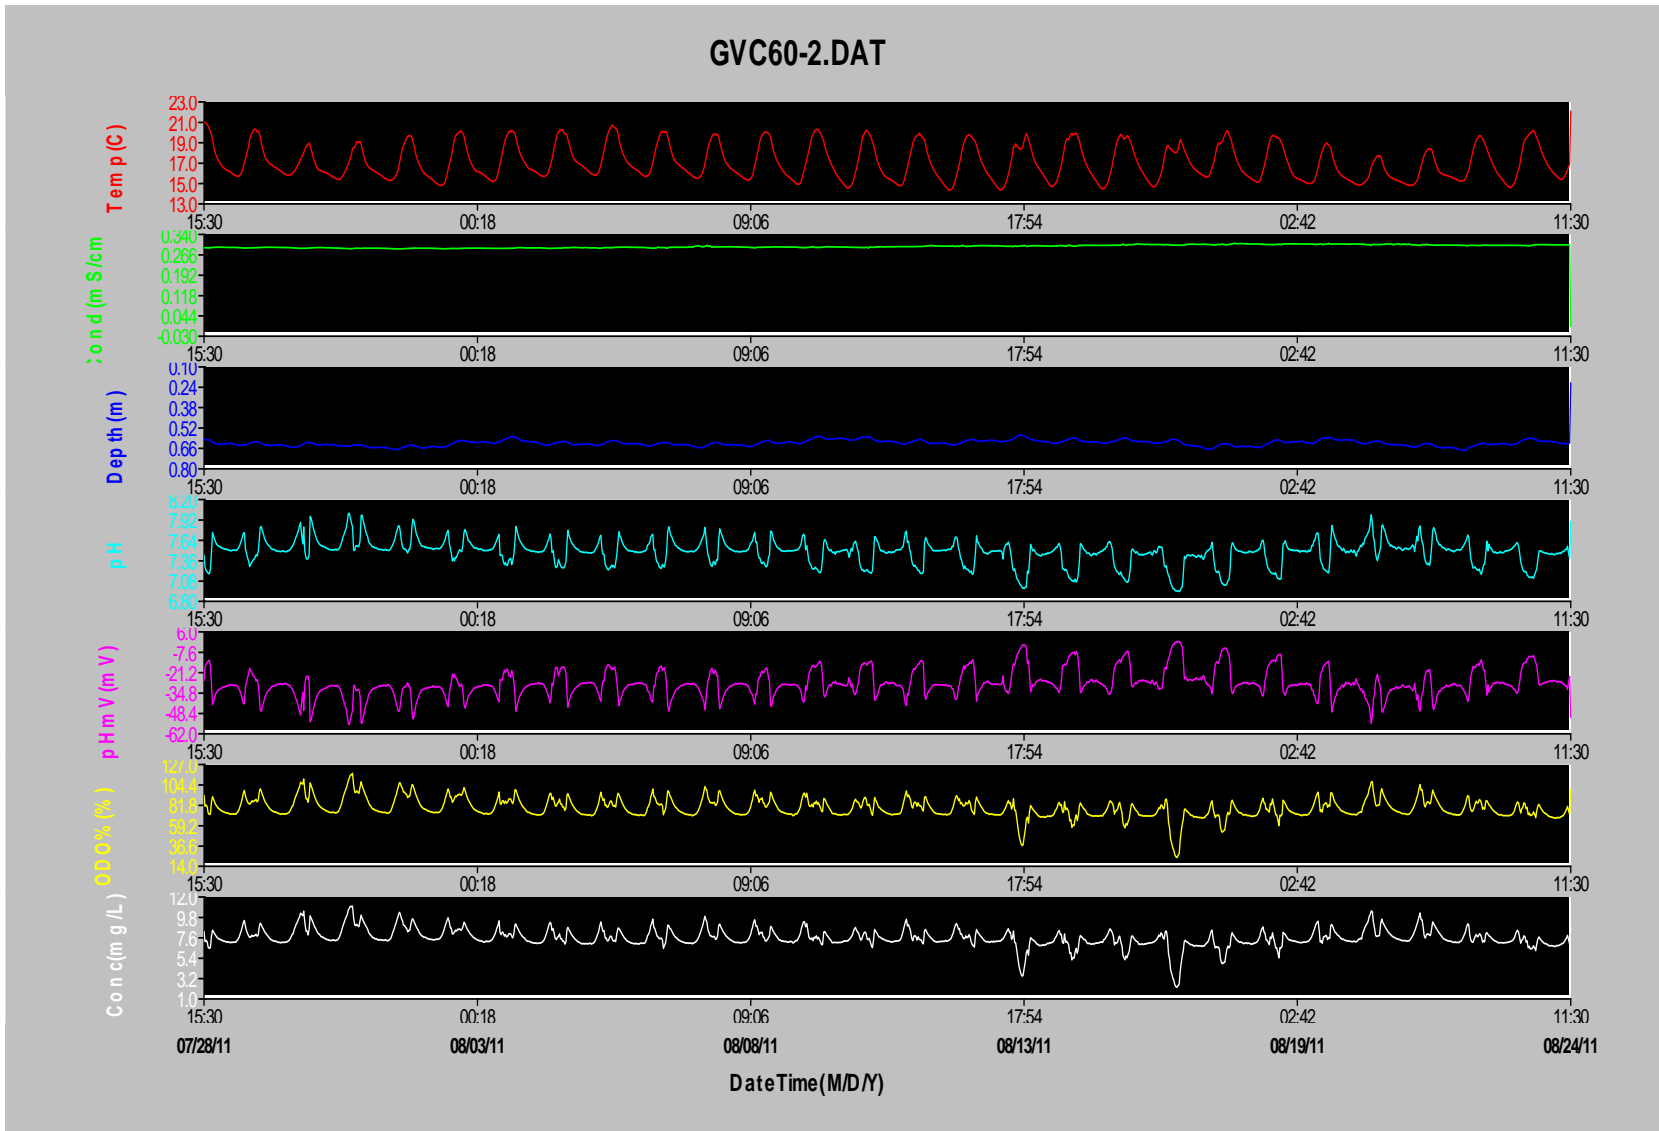
Figure B-27. Continuous water quality data for GVC60, Green Valley Creek downstream of Green Valley Road bridge (7/28-8/24/11)

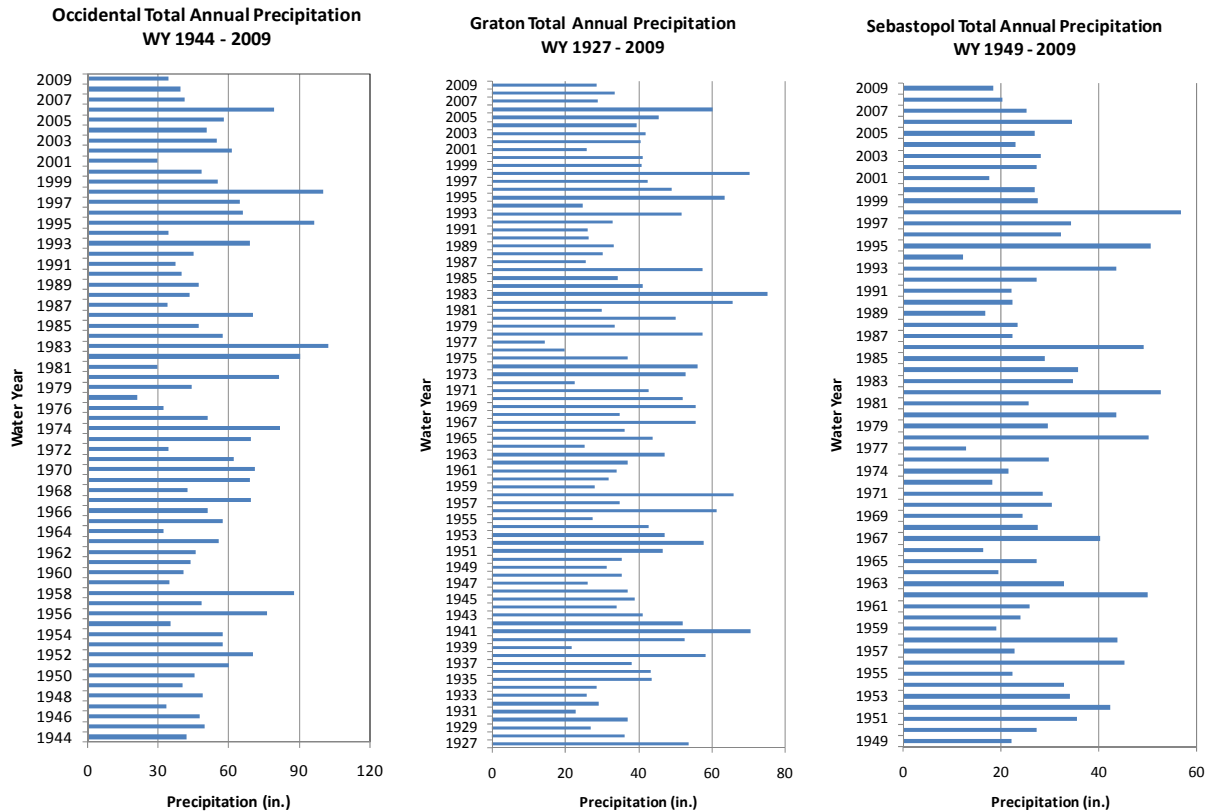
Figure C-5 a-c. Distribution of annual rainfall at Occidental, Graton, and Sebastopol over long-term periods of record.

Another trend suggested as likely to occur with climate change is increased magnitude of high-rainfall events. Long-term records can also be used to examine whether rainfall events of high magnitude occur more frequently in recent years compared to earlier in the period or record.

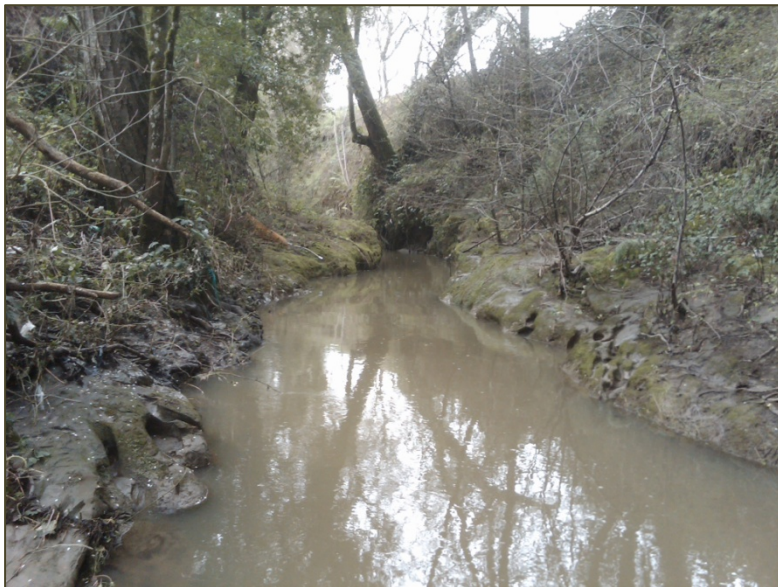
*Incised channel. Photo courtesy of Matt O'Connor.*

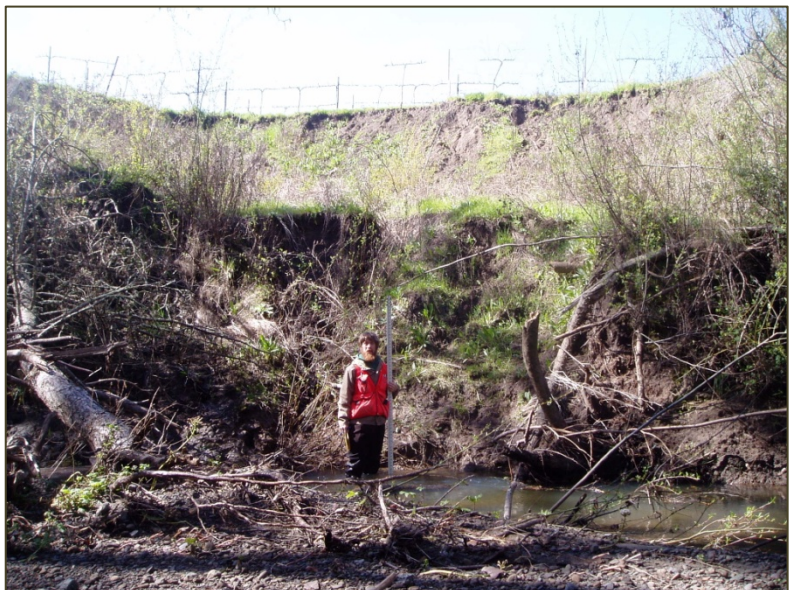
*Bank Collapse/Erosion. Photo courtesy of Matt O'Connor.*

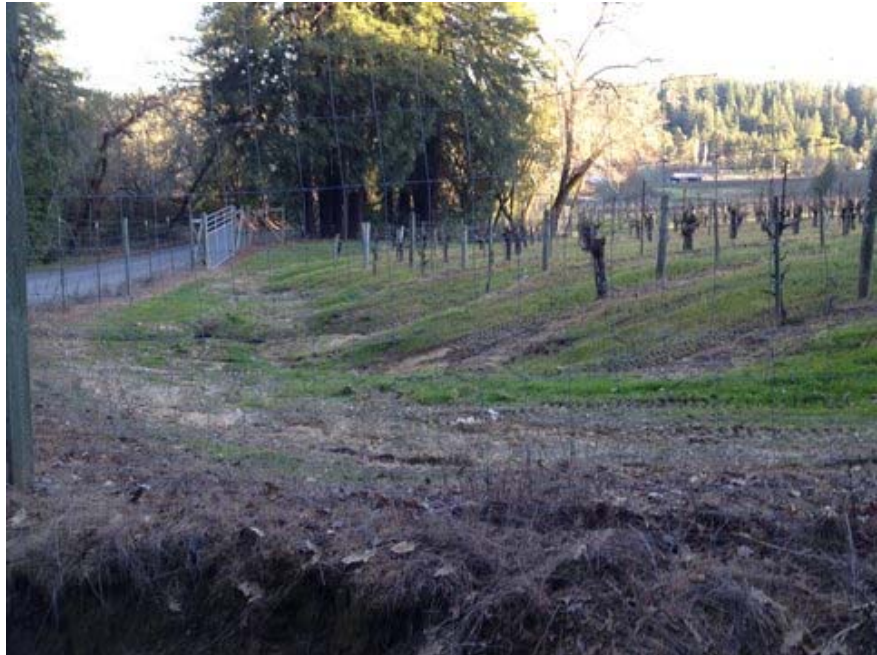
*Vineyard drainage. Photo courtesy of Matt O'Connor.*

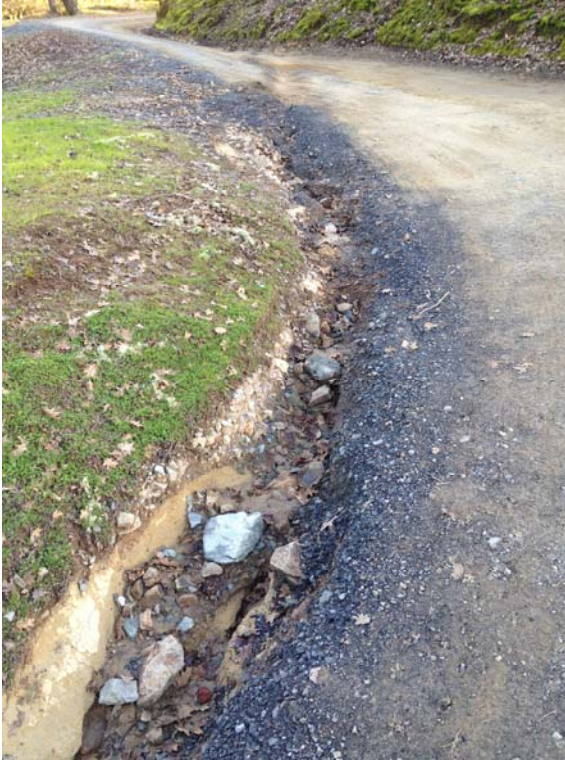
*Inboard ditch. Photo courtesy of Matt O'Connor.*

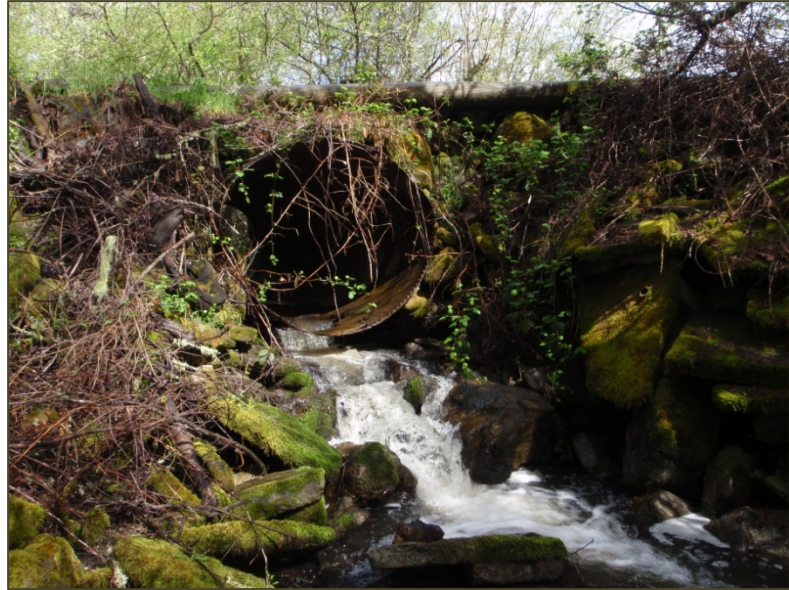
*Stream crossing in poor condition on upper Green Valley Creek.  
This crossing is a barrier to coho salmon passage.*

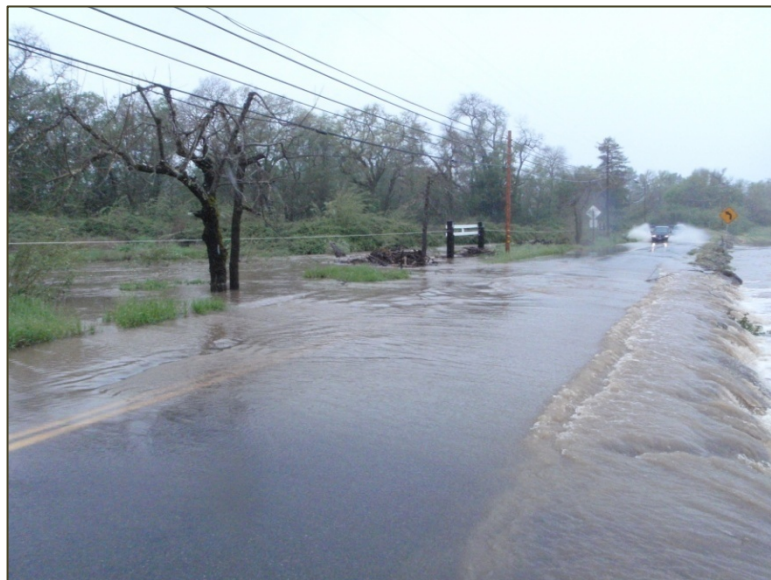
*Flooding on Green Valley Road*

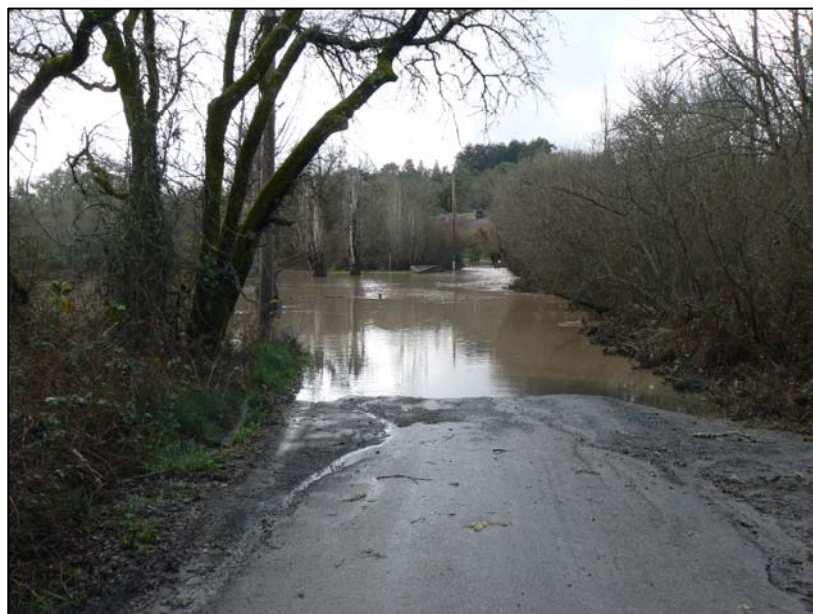
*Flood flows at Ross Station Road, March 2011*

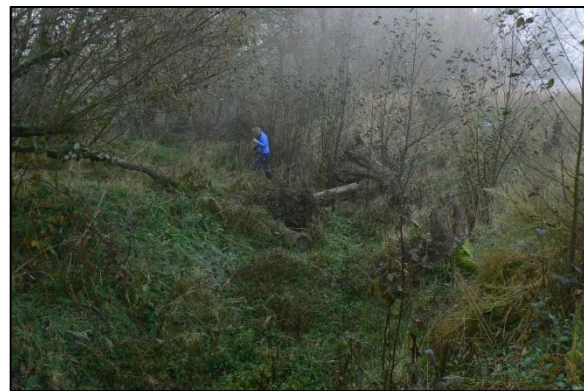
*Figure 1. A naturally occurring high-flow side channel augmented with large wood structures in Salmon Creek (photo by GRRCD).*
