**THE SALMON CREEK WATERSHED
ASSESSMENT AND RESTORATION PLAN**

Grant Agreement P0230439

Version 1, March 31 2007

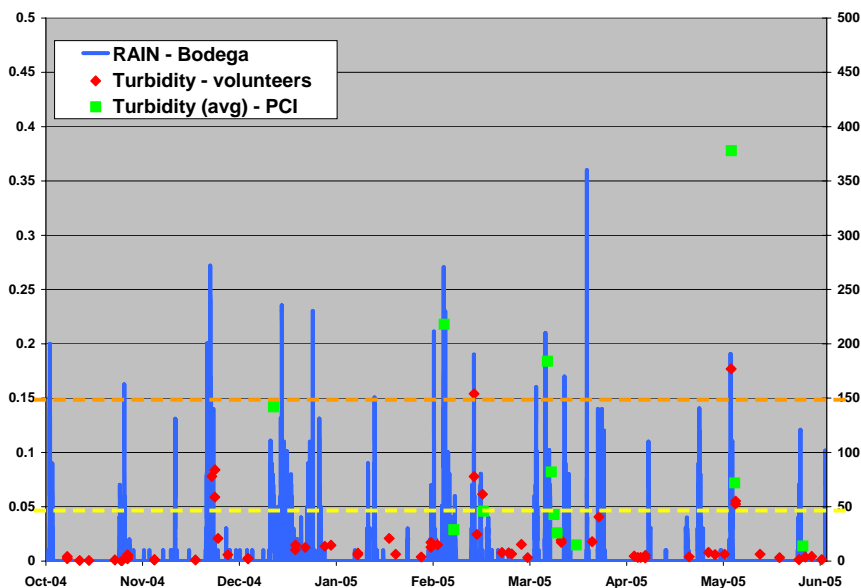
The data collected shows periods of extended turbidity after each rain event. The image below combines rainfall totals and turbidity measurements by the volunteers and PCI staff with the severity of impacts to salmonids shown in the dashed yellow (low impact) and orange (detrimental) lines. The turbidity measurements collected by PCI are clearly above the detrimental level on several occasions.

Individual storm event data details the trend for turbidity in the watershed. Turbidity levels remain high, above the detrimental levels even several hours after the heaviest rainfall. (See Appendix A for additional images.)

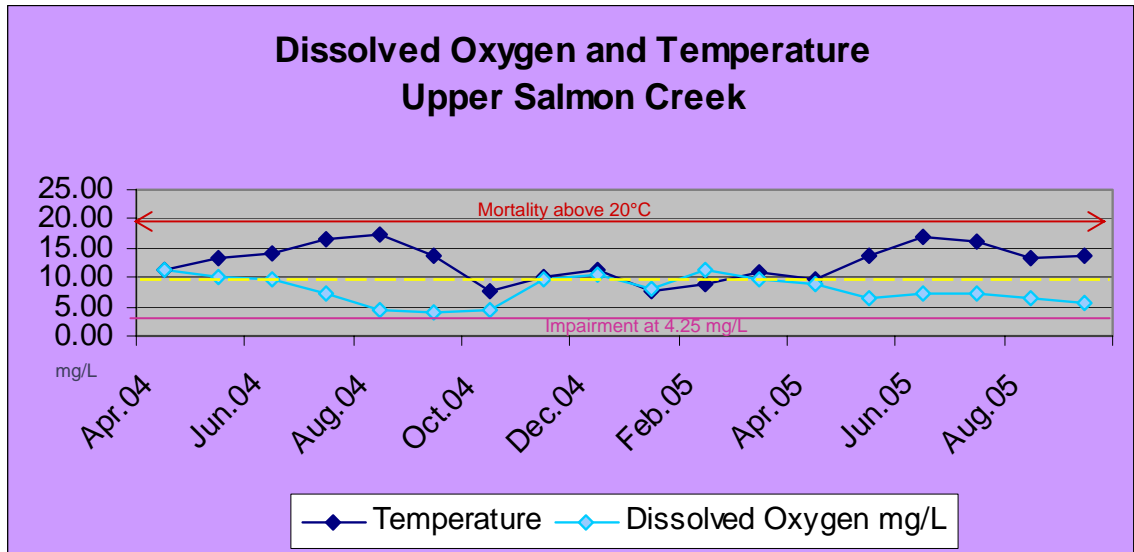
Graph 4.3 Dissolved Oxygen and Temperature in Salmon Creek 2004-2005

If fish have suitable habitat conditions accessible nearby, they can move to cooler waters. During the warmer months the data often shows a spike in dissolved oxygen with levels above 100%. Supersaturation of oxygen is present in the waters due to the rapid growth of algae. Often these waters are typically nutrient-rich, slow moving or stagnant and are warmer than acceptable for salmonids. The supersaturated waters quickly change as the algae dies off. The decomposition of the organic plant matter requires the use of oxygen resulting in critically low levels of oxygen. Many reaches along Salmon Creek become quite shallow or stagnant during the summer months as water levels drop. Again, the critical issue is the availability of suitable habitat. Fish need suitable habitat year-round and for all age groups of fish living in the creek. The data shows good conditions in the winter breeding months and scattered areas of good habitat during the summer months. Graphs 4.3 – 4.10 below show dissolved oxygen and temperature for all the reaches of mainstem and the tributaries.

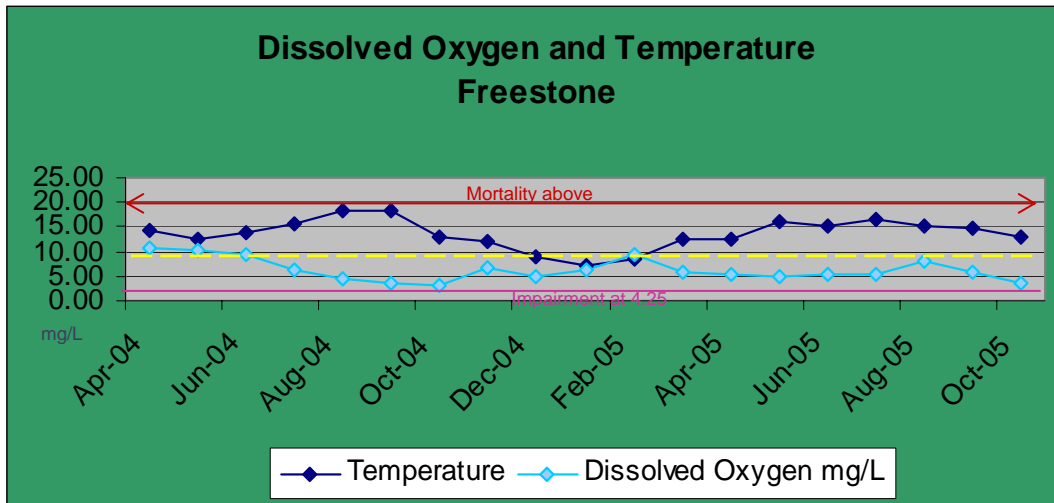
Graph 4.4 Dissolved Oxygen and Temperature at the Freestone Site 2004-2005

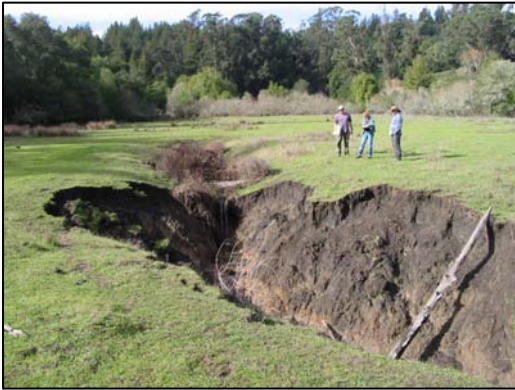
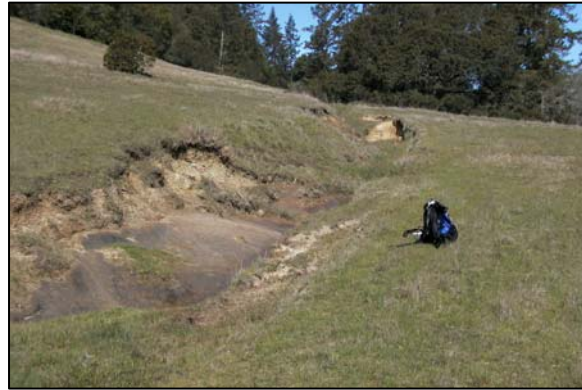
Figure 5-2. Number of sites inventoried in each category by potential sediment yield. Sediment production for each category are: Low yields = 0-100 yds³, Medium yields = 100-1,000 yds³, and High yields = >1,000 yds³. Unusual climatic conditions or changes to a site could lead to accelerated erosion processes and increase the estimated yield.

Two important considerations in determining the severity of erosion sites are the potential sediment yield (Figure 5-2) and the erosion activity (Figure 5-3). Potential sediment yields were ranked into three categories (high, medium, and low) based on the volume of sediment they are likely to mobilize and transport to the stream system. Erosion activity was also ranked similarly, and is based on evidence of recent soil loss and feature movement (e.g. headcut moving upstream, bank sloughing).

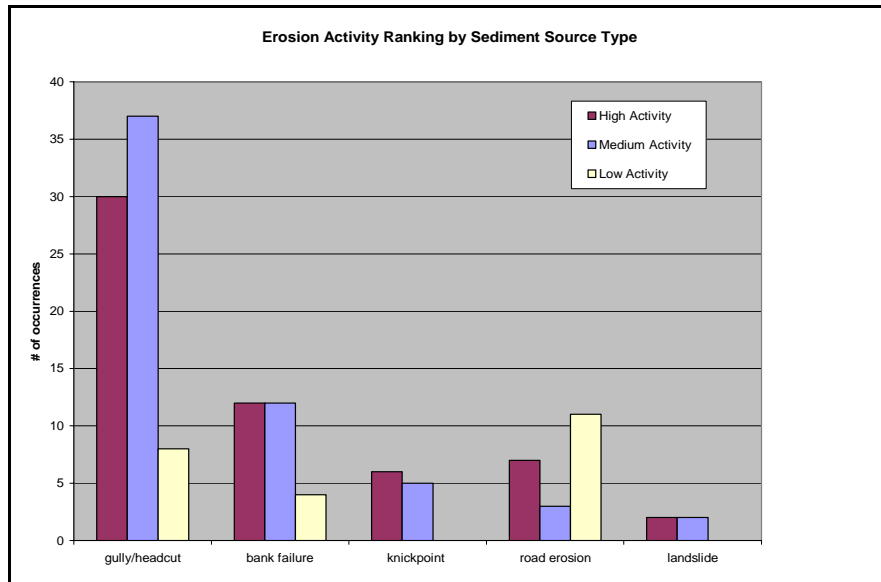
Figure 5-3. Number of sediment sources ranked by erosion activity and type. Highly active sites appear to have recently lost material, are devoid of vegetation, and are unstable. At the other end, low activity sites do not show signs of recent movement and are stabilizing through vegetation establishment or changes in erosive forces.

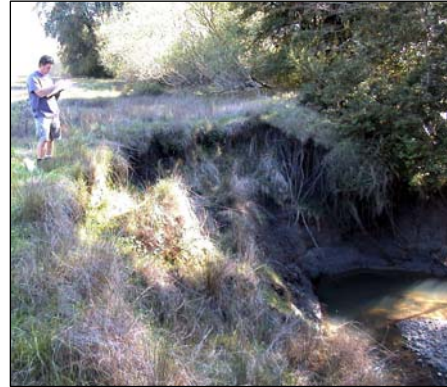
Figure 5-4. Distribution of repair priorities by sediment source type. Gullies and headcuts are the highest priority because of their higher sediment yields. Gullies also irreparably damage productive grassland and forests. Instream knickpoints that will lead to additional headcuts and gullying were also chosen as high priority sites. Landslides are also high priorities because of the fine sediment they produce though it is unlikely that they can be repaired.

Overall the erosion activity of each source type is ranked higher than the yield or repair priority (Figure 5-4). This is especially true of streambank failures. Eroding banks often

Bank erosion is a finite, self-managing process. It is also normal, and desirable from a habitat standpoint, for incised streams to go through a period of widening after incision. The volume of sediment derived from a single bank failure site is usually between 50 and 300 cubic yards, as compared to gullies that produce 500-5000 cubic yards. Thus gullies and headcuts were chosen as high priority repairs over the active bank erosion sites (Figure 5-5, Table 5-4).

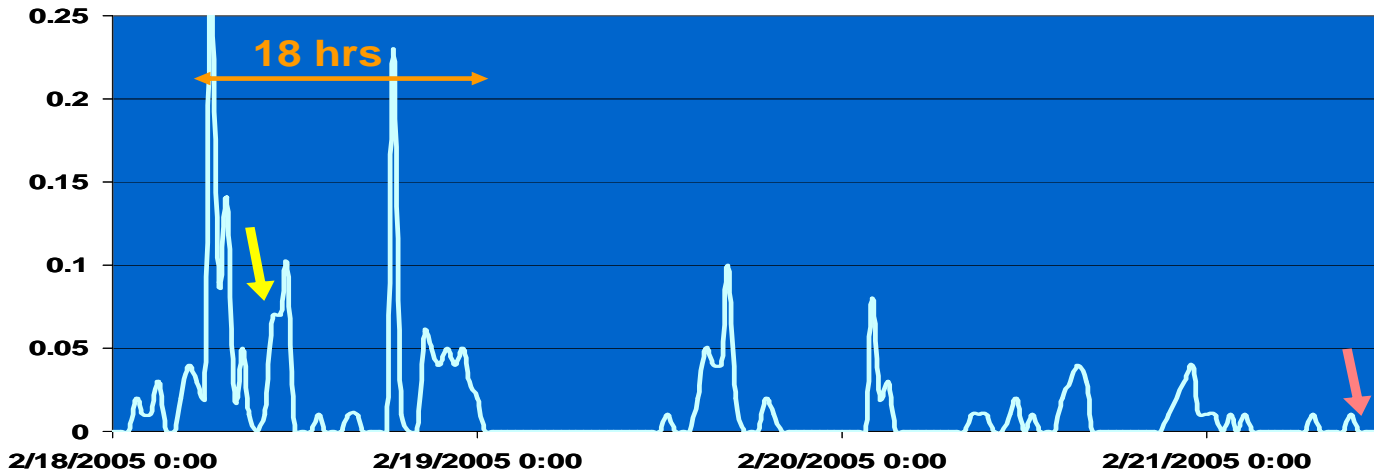
Results of the turbidity measurements taken on February 18th and 21st. Rainfall during the storm event in light blue with the colored arrows corresponding to turbidity samples taken above

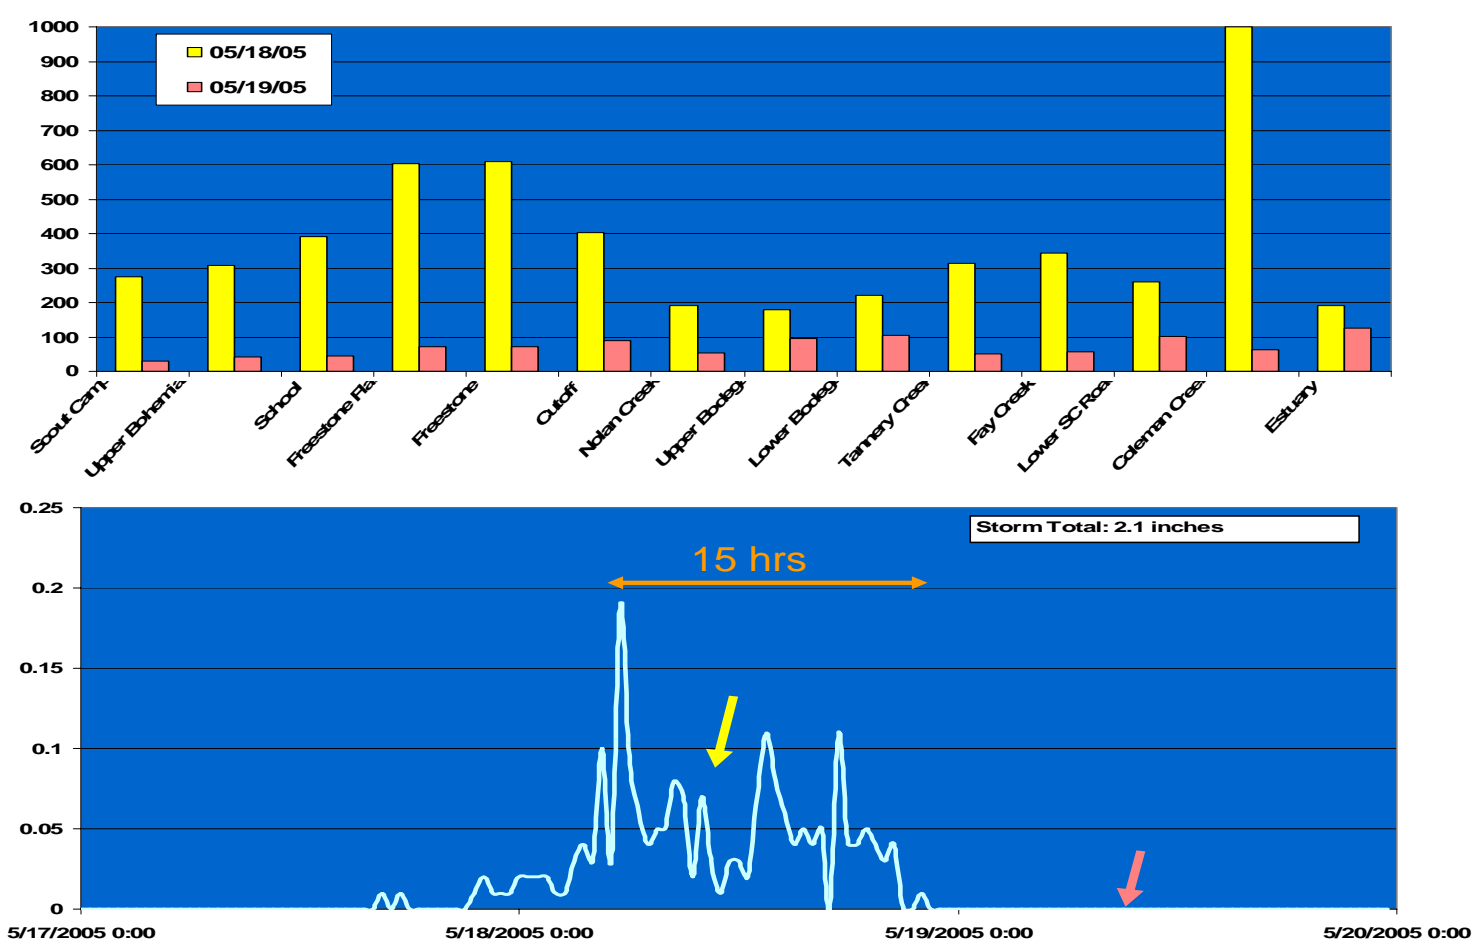
Results of the turbidity measurements taken on May 18th and 19th.
