The Estero Americano Watershed Management Plan

Version 1, February 2007

**Prepared by:
The Gold Ridge Resource Conservation District**

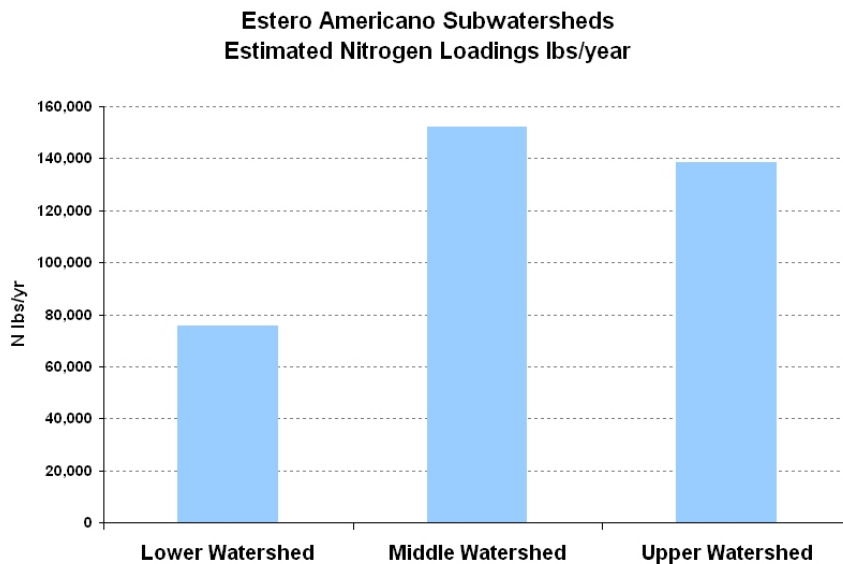
Figure 3-10. Annual Nitrogen loading in the three Subwatersheds.

Chart 3-1. N Loading (lbs/yr) by Source

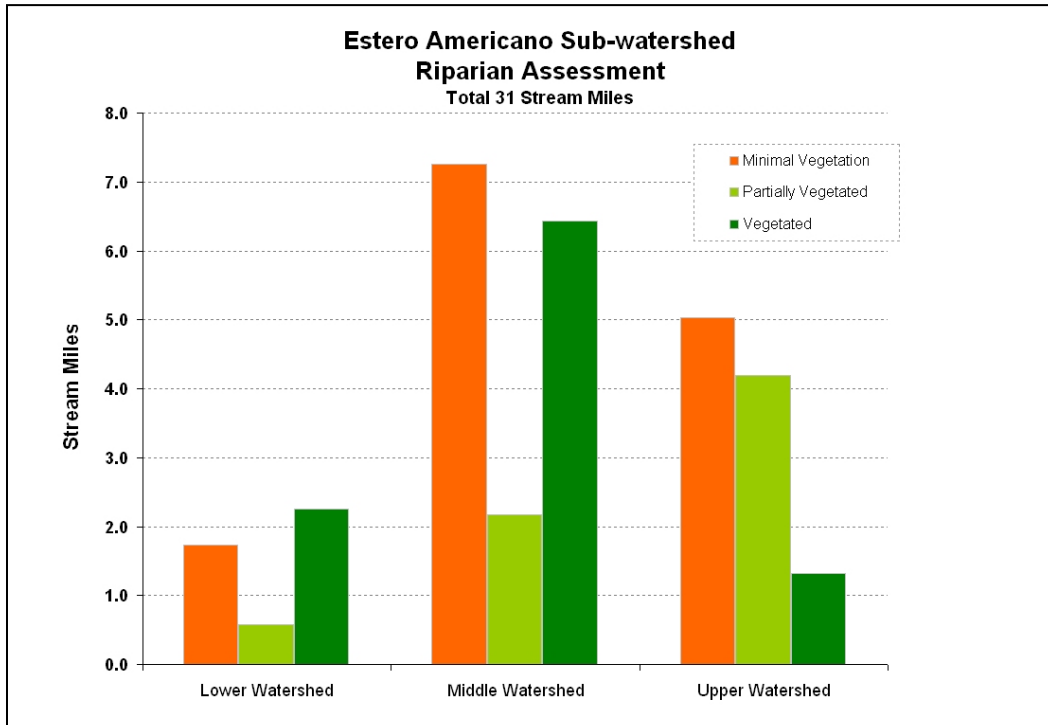
Figure 1-1. Riparian Conditions by Sub-watershed for USGS blue-line streams.
