Stream Inventory Report

Coleman Valley Creek

Salmon Creek Watershed
Sonoma County, California

Survey: Summer 2002
Final Report: September, 2004

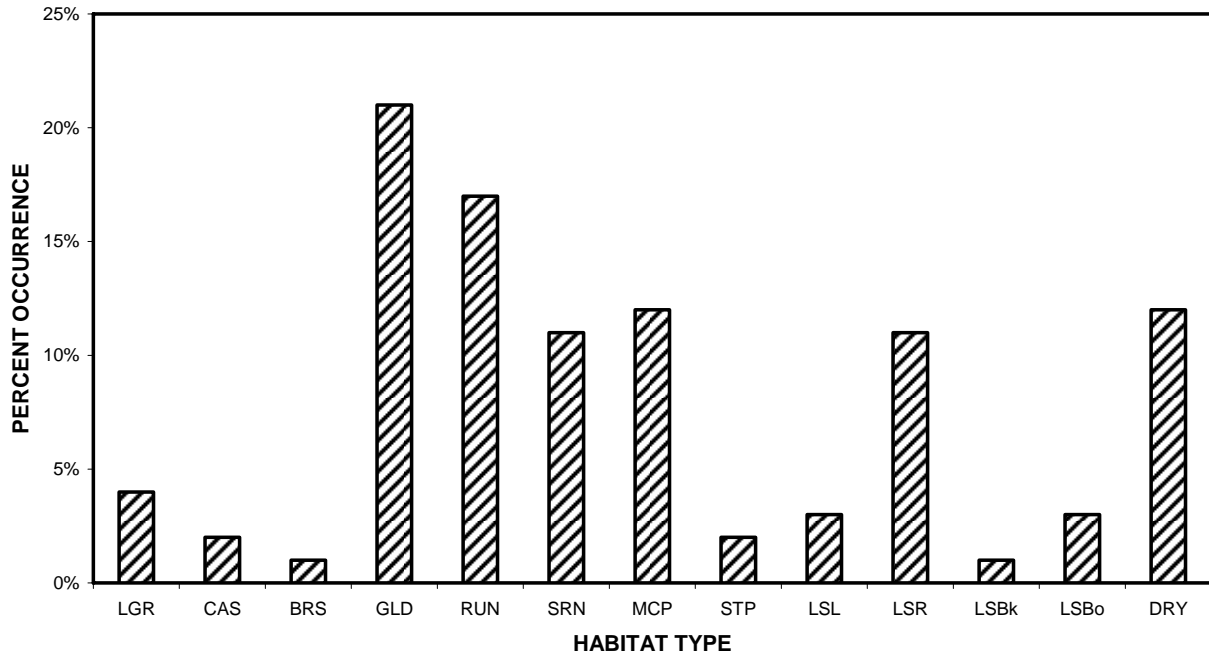
GRAPH 3. Level IV habitat unit types by percent occurrence.

COLEMAN VALLEY CREEK HABITAT UNIT TYPES BY PERCENT OCCURRENCE

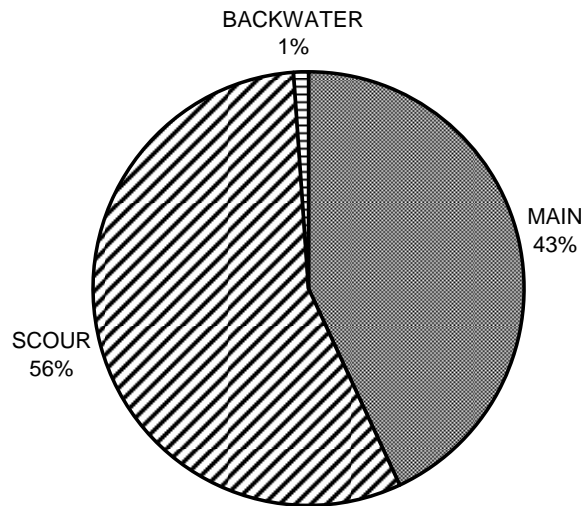
GRAPH 4. Level I pool habitat types by percent occurrence.

COLEMAN VALLEY CREEK POOL HABITAT TYPES BY PERCENT OCCURRENCE

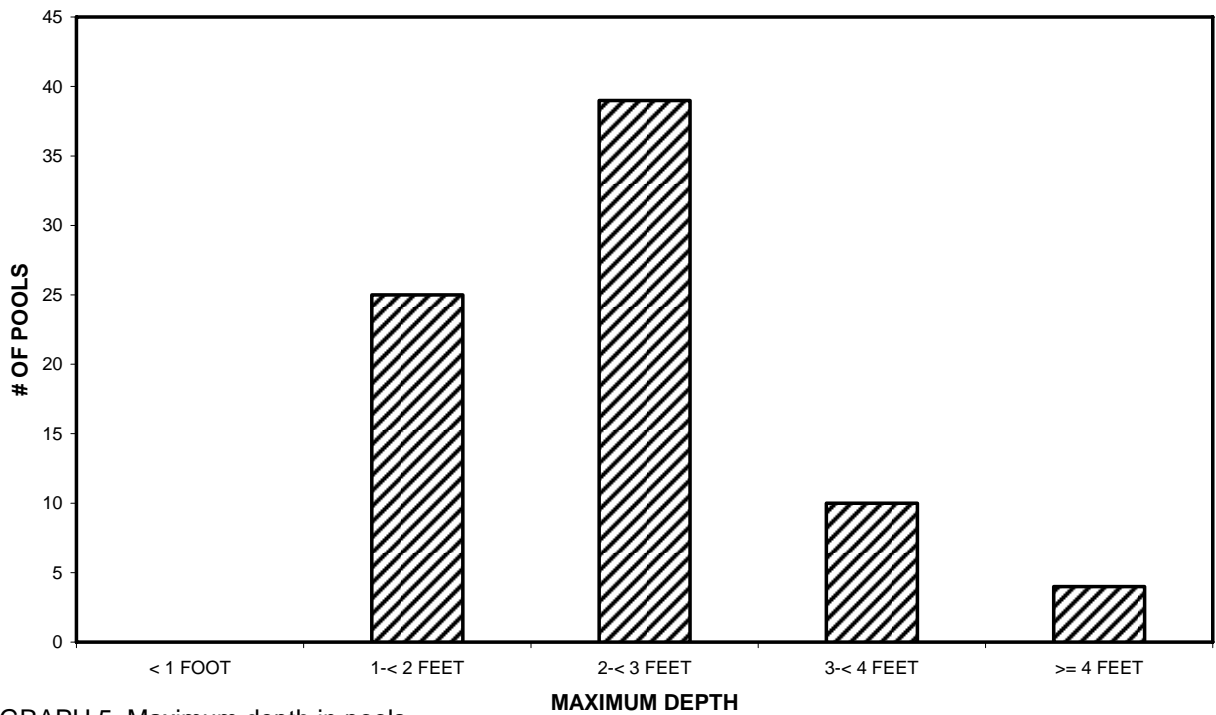
GRAPH 5. Maximum depth in pools.

COLEMAN VALLEY CREEK MAXIMUM DEPTH IN POOLS

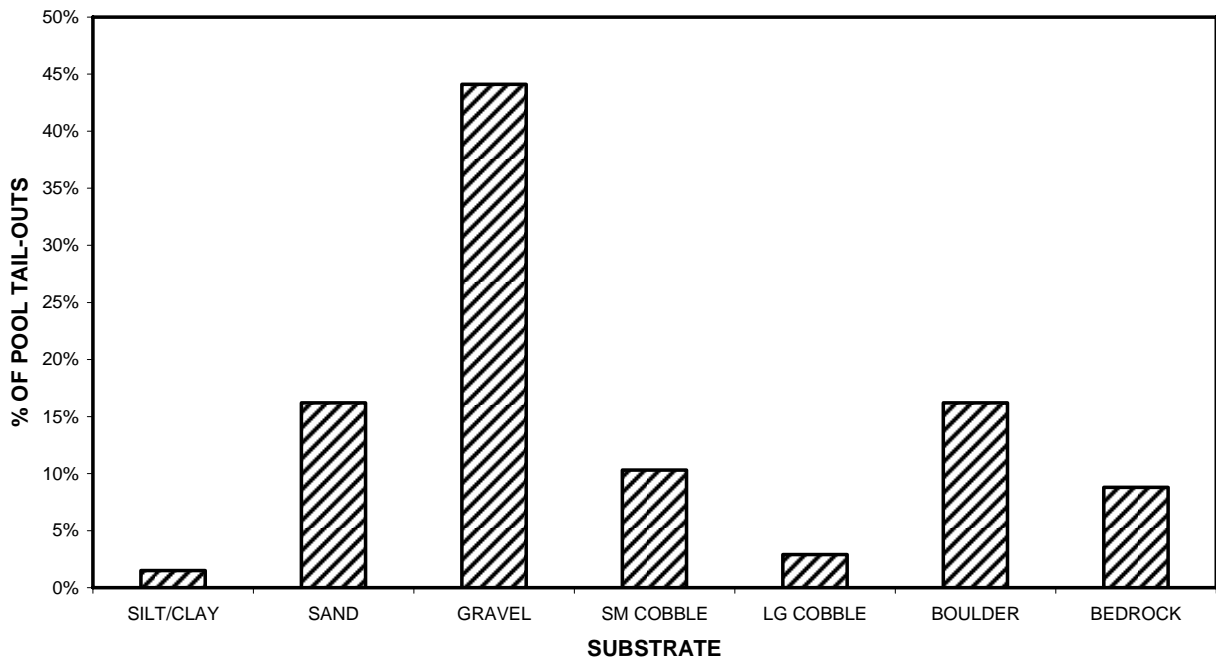
GRAPH 8. Substrate composition in pool tail-outs.

The depth of cobble embeddedness was estimated at pool tail-outs. Of the 54 pool tail-outs measured, 4 had a value of 1 (13%), 33 had a value of 2 (55%), 11 had a value of 3 (19%) and 1 had a value of 4 (3%). 5 (10%) riffles rated a 5 (unsuitable substrate type for spawning). On this scale, a value of one is best for fisheries. Gravel was the dominant substrate observed at pool tail-outs (Graph 8). Table 9 describes percent embeddedness by reach.

COLEMAN VALLEY CREEK SUBSTRATE COMPOSITION IN POOL TAIL-OUTS

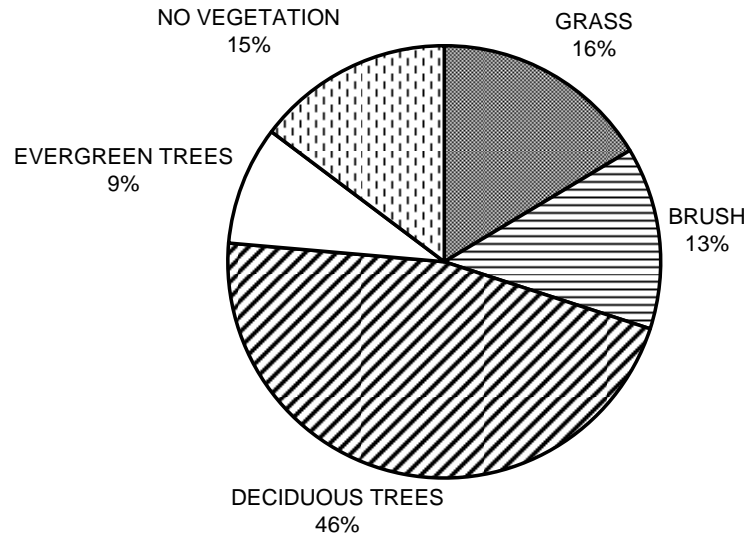
GRAPH 11. Dominant bank vegetation in survey reach.

COLEMAN VALLEY CREEK DOMINANT BANK VEGETATION IN SURVEY REACH
